Date : may 27th 2009
Concerns : Situation of the water pumps in ward Sunga, district Lushoto, Tanzania
Reference : Herman Erdtsieck MamboViewPoint
e-mail : info@MamboViewPoint.org
annex : statistical information of the population of Sunga
review of the pumps in Sunga
situation of the pumps to be replaced
inspection of 3 of the 9 recently replaced pumps

introduction

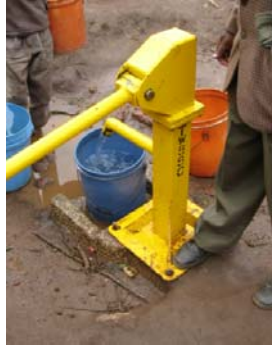
<i>Inspection of 3 of the 9 just replaced pumps</i>				
1	Masereka	-4.54437 38.24281	Pump is just replaced by the government, but the nuts for fixing the pump are missing, by which it is likely to break again in short term.

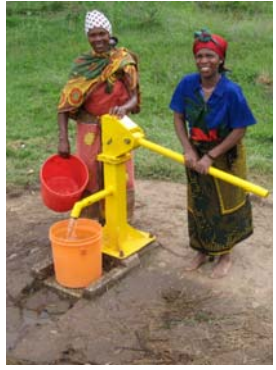
2	Mambo	-4.51259 38.21147	Just replaced, is working well. Place is near Tema
