Date : may 27<sup>th</sup> 2009  
Concerns : Situation of the water pumps in ward Sunga, district Lushoto, Tanzania  
Reference : Herman Erdtsieck MamboViewPoint  
e-mail : [info@MamboViewPoint.org](mailto:info@MamboViewPoint.org)  
annex : statistical information of the population of Sunga  
review of the pumps in Sunga  
situation of the pumps to be replaced  
inspection of 3 of the 9 recently replaced pumps

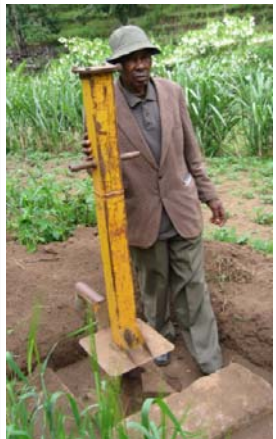
<b>Annex 3: Inventory of broken pumps</b>				
<i>Nmb</i>	<i>Village</i>	<i>GPS and altitude</i>	<i>Situation</i>	<i>Pictures</i>
1	Sunga	-4.52093 38.23795 1886 m	The borehole looks ok, and old pump is placed but is not working any more.

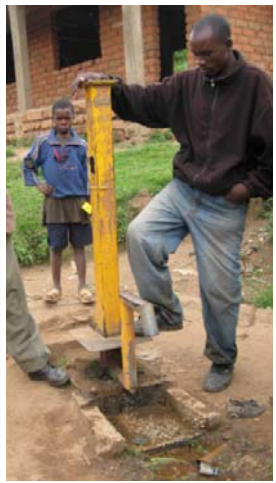
2	Masereka	-4.54179 38.23856 1826 m	There is a pump placed and is working a little but the spring is broken and it is not used. There are rumours the water is smelling. During inspection the smell is not detected.

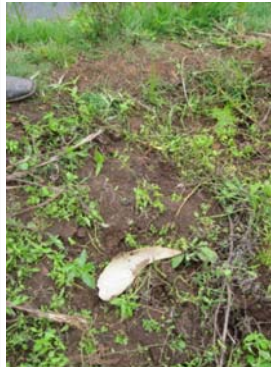
6	Tema	-4.53072 38.21417 1695 m	It is said that there has been a working pump 6 month ago. Only some broken plastic pipe is left. The exact position of the borehole is covered by soil and has to be located.

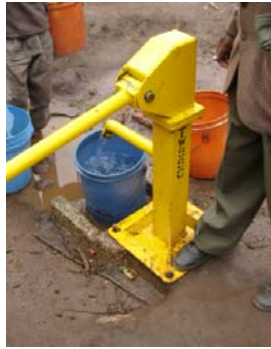
<b><i>Inspection of 3 of the 9 just replaced pumps</i></b>				
1	Masereka	-4.54437 38.24281	Pump is just replaced by the government, but the nuts for fixing the pump are missing, by which it is likely to break again in short term.

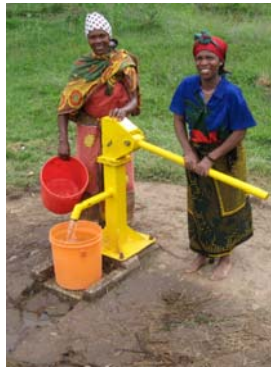
2	Mambo	-4.51259 38.21147	Just replaced, is working well. Place is near Tema
