Date : January 7th 2011
Concerns : Project drinkingwater for ward Sunga, district Lushoto, Tanzania
Reference : Herman Erdtsieck MamboViewPoint
e-mail : info@MamboViewPoint.org
annex : statistical information of the population of Sunga
review of the pumps in Sunga
situation of the pumps to be replaced
inspection of 3 of the 9 recently replaced pumps

Annex 2: review of the pumps in ward Sunga

Annex 3: Inventory of broken pumps				
<i>Nmb</i>	<i>Village</i>	<i>GPS and altitude</i>	<i>Situation</i>	<i>Pictures</i>
1	Sunga	-4.52093 38.23795 1886 m	The borehole looks ok, and old pump is placed but is not working any more.

Inspection of 3 of the 9 just replaced pumps

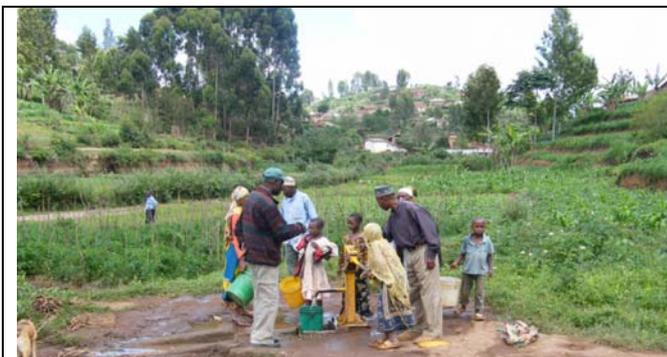
Water is found in the valleys not far below the surface.

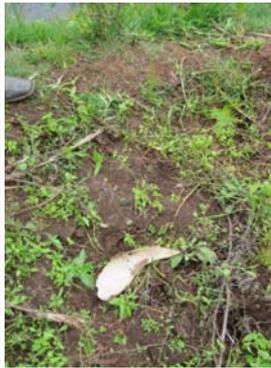
6	Tema	-4.53072 38.21417 1695 m	It is said that there has been a working pump 6 month ago. Only some broken plastic pipe is left. The exact position of the borehole is covered by soil and has to be located.

Actual situation on June 22 th 2010		The borehole is found but not cleared. Distance from ground level till bottom of the borehole: 30 cm, no water.

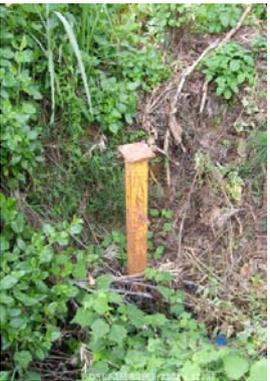
16	Manolo (1)	S4.60921 E38.21980	Spring pump is damaged by landslides and not working anymore. People fetch water from a small river.

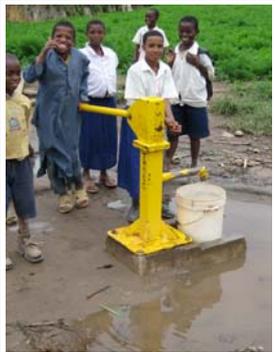
13	Mambo	-4.51118 38.22400	Pump is just replaced by the government, but the nuts for fixing the pump are not well fixed, and it is likely to break again in short term.
